Problem

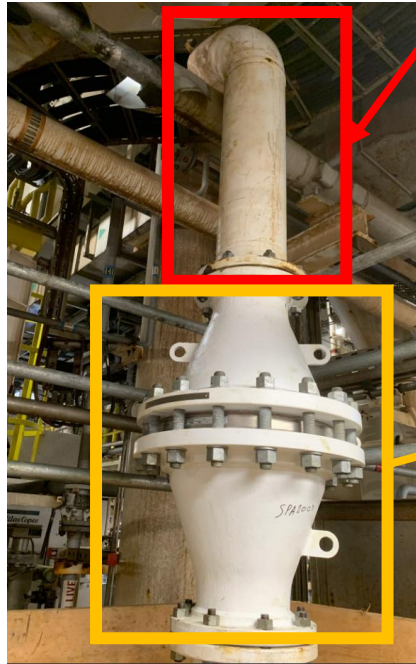
Corrosion from this pipework section deposited at downstream of flame arrestor (FA)

- Replace piping for different material piping (currently carbon steel)?
- Apply internal coating?
- Inspect and clean internals periodically? Not very practical or realistic long-term
- 316 stainless direct replacement
- New Carbon steel direct replacement with internal coating
- Current carbon steel pipe repaired in-situ with internal coating

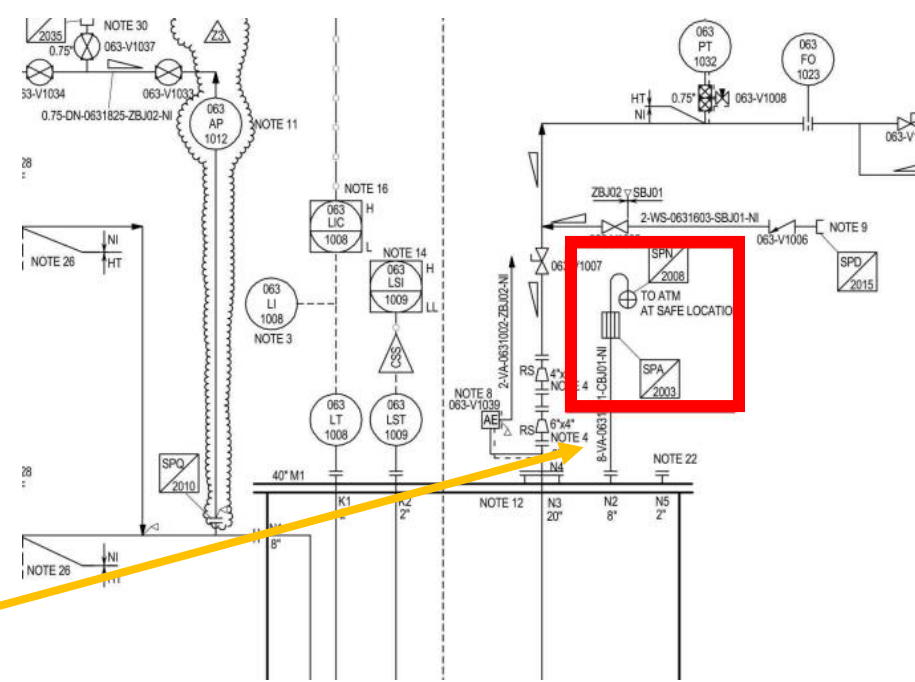
Non-hazardous, open drain system

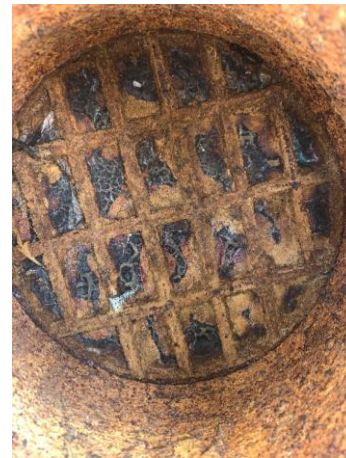
Corrosion deposits
